# Operating Experience Weekly Summary 97-44

*October 24 through October 30, 1997*

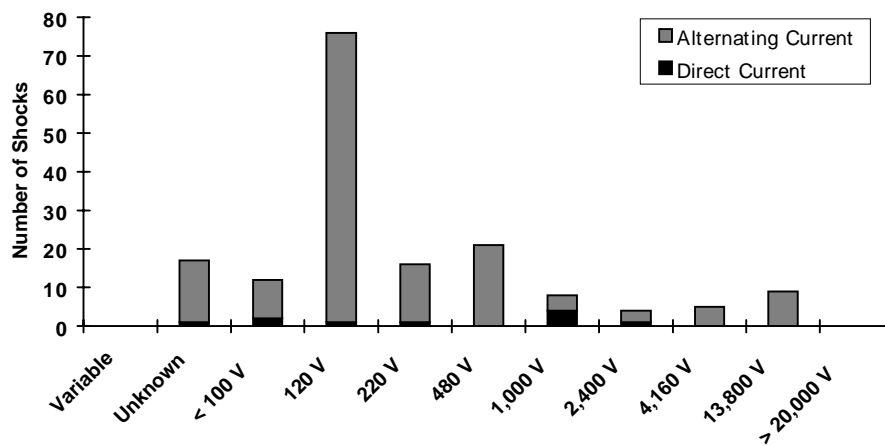
OEAF engineers reviewed selected electrical occurrences from the ORPS database from October 1, 1990 through September 30, 1997, for reports that resulted in electrical shocks without any injuries and found 168 reports. We compared the number of shocks caused by voltages in various ranges to the total number of electrical occurrences in the same range. We determined that significantly more electrical shocks resulted from voltage ranges with alternating current at 120-volts or below, and near 1,000-volts of direct current. Figure 3-1 shows the voltage distribution for electrical shocks.

**Figure 3-1. Voltages Involved in Electrical Injuries<sup>1</sup>**

<sup>1</sup> This data was developed based on 742 occurrences. OEAF engineers reviewed these occurrences and found 168 reported shocks.
